Monday April 11, 2016 Safety incident / fatality

November, 2017

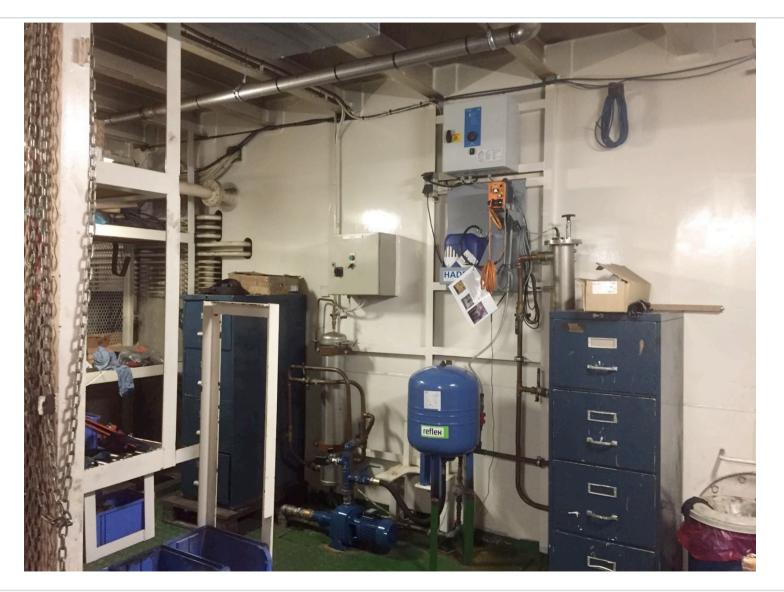
- Employee was found unconscious in the engine room nearby the pump. He could not revived and passed away.
- On the moment he was found the pump was changed, fuses were in, electrical wiring partially connected and the switch was on

Overview pressurized water system compartment

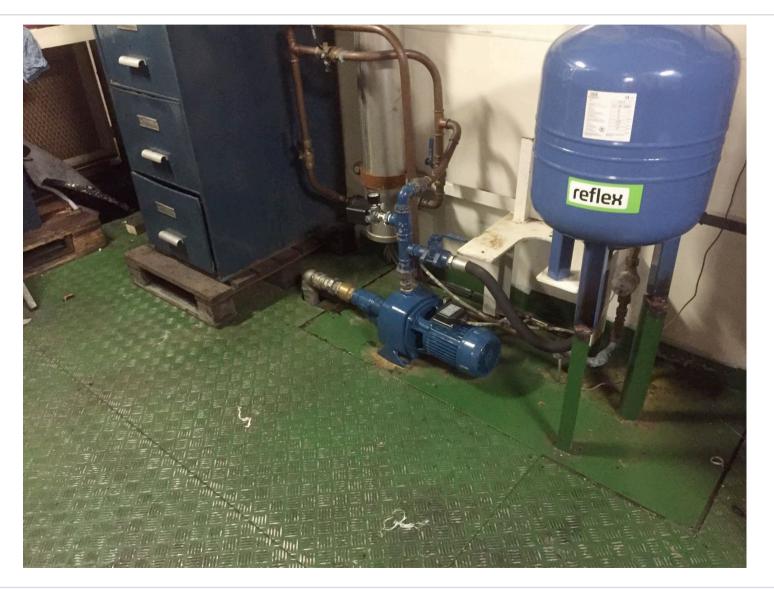
Hydropump pressurized water system

- Investigation learned that after changing the pump the employee himself switched the power of the hydro pump installation on and also placed the fuses themselves in the control cabinet (in another room). During this:

- there were still "open" electrical wires, not capped or mounted, the hydro installation was not safe at that moment;
- Autopsy revealed that the victim had a mark in his hand, where the electricity has entered his body and led to the electrocution. So there was direct contact with electricity.

- Introduced lockout/tagout procedure to be more specific on personal safety.
 - Renewed LMRA card with question about involving a trained specialist like Electrician
